[2010 Chevrolet Camaro](#) | [Camaro \(VIN F\) Service Manual](#) | [Engine](#) | [Preliminary Information](#) |
Document ID: 2477997

#PIP4499D: Start Up Lifter Tick Noise After Engine Has Been Off For 2 Hours Or More - AFM Engines - (May 25, 2010)

Subject: Start Up Lifter Tick Noise After Engine Has Been Off for 2 Hours or More - AFM Engines

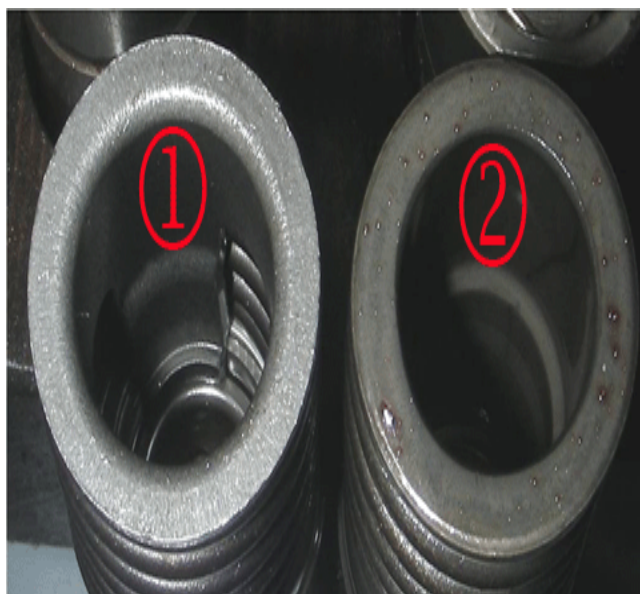
AFM Lifters:

- 1) Eaton - 3 Slots in Tube
- 2) Delphi - No Slots in Tube

- If an extended duration tick (10 seconds or more) is experienced on every cold start but the noise diminishes within a few minutes, determine if the noise occurs at cam speed (half of crank speed). If so, isolate the area that the noise is coming from. If the noise is too excessive or if the customer does not want to wait for the updated lifters mentioned above, use the information below to determine if the suspect lifter pack is equipped with Eaton lifters or Delphi lifters. Replace all of the lifters on both banks if Eaton lifters are present. Replace all of the lifters on the suspect bank if Delphi lifters are present. The new lifters from GMSPO should be Delphi lifters.

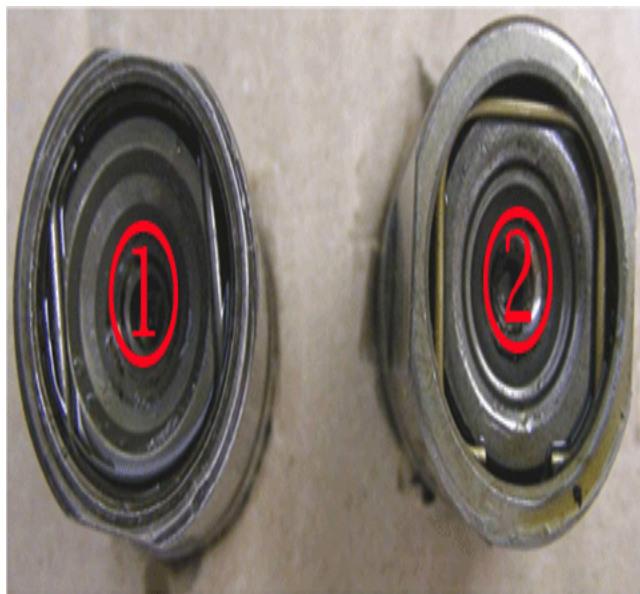
Non-AFM Lifters:

- 1) Eaton - 2 Parallel Clip Wires Visible
- 2) Delphi - 3 Clip Wires Visible
