# #13113: Service Update for Inventory and Customer Vehicles - Convertible Top Cosmetic Blemish - Expires with Base Warranty - (Apr 16, 2013)

Models: 2013 Chevrolet Camaro Convertible

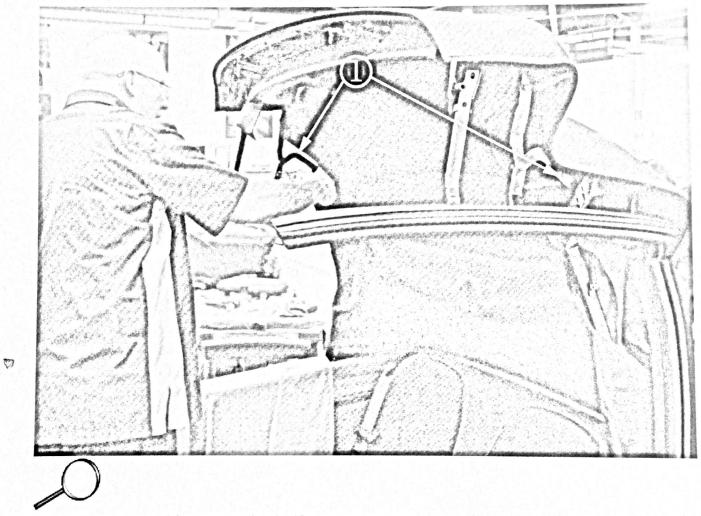
- 1. Open the convertible top to the half-open position.
- 2. Locate the convertible top control link (1).

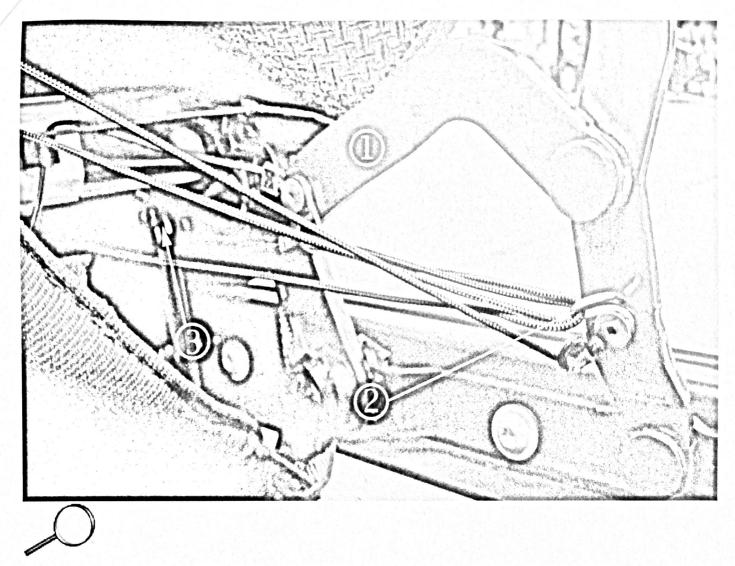
Note: (1) Control Link (2) Control Link Front Eye Loop (3) Control Link Rear Eye Loop 3. Locate the control link rear eye loop (3). Refer to the inside of the control link to locate the rear eye loop.
