Recall Bulletin

PRODUCT SAFETY RECALL

SUBJECT: Positive Battery Cable Routing - Reroute

MODELS: 2010 Chevrolet Camaro
Equipped with a V8 Engine

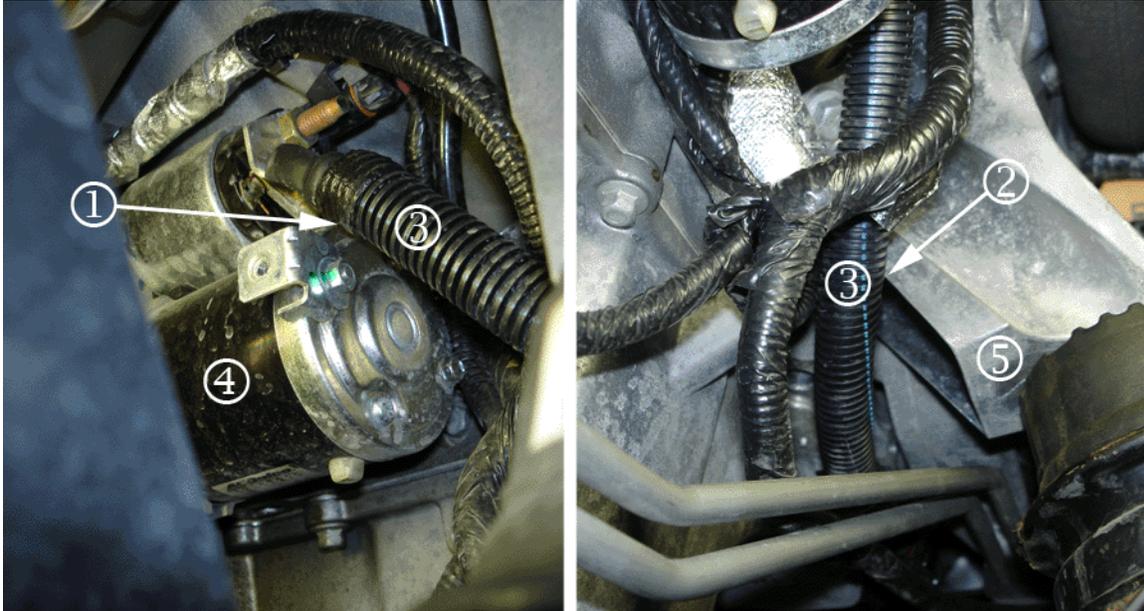
- (1) Battery Positive Starter Cable-to-Starter Contact Area
- (2) Motor Mount-to-Battery Positive Starter Cable Contact Area
- (3) Battery Positive Starter Cable
- (4) Starter
- (5) Motor Mount

4. Locate where the battery positive starter cable (3) contacts the starter (4) and motor mount (5). Refer to the illustration above.
5. Remove starter terminal nut and the battery starter cable from the starter terminal.
6. Move the battery starter cable away from the motor mount.
