#PI0319: Chipped Paint on Rear Compartment Lid at Spoiler Mounting Area - (Dec 2, 2010)

Subject:	**Chipped Paint on Rear Compartment Lid at Spoiler Mounting Area**
Models:	**2010-2011 Chevrolet Camaro**

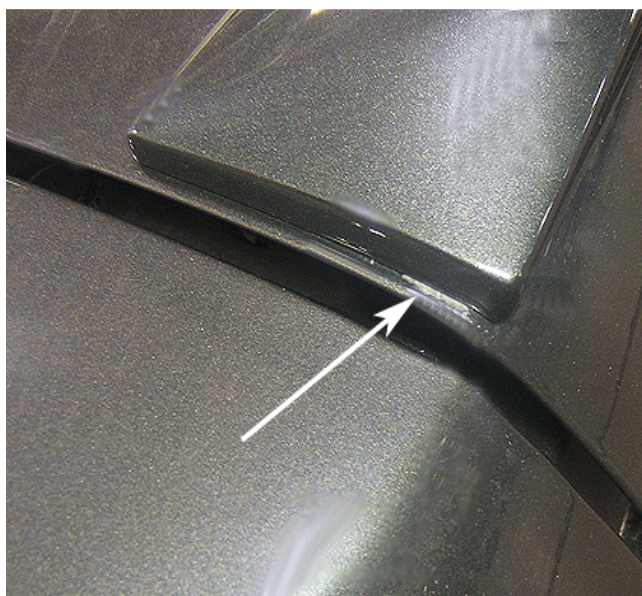
Some customers may comment that the rear compartment lid mounted spoiler is making contact with the rear compartment lid. This contact condition may cause paint damage to the rear compartment lid.

This condition may caused by the spoiler gaskets and spacers having insufficient material thickness.

A spacer kit with revised gaskets and spacers has been made available to correct this condition. Use the following steps to remove the old gaskets and spacers from the spoiler and to install the new spacer kit onto the spoiler.
